# Manhole Inspection Summary

Manhole # S39KK\_011MH

Insp Date: **1/18/08 1:34 PM**

**Location** Address: **1701 ASQUITH ST**

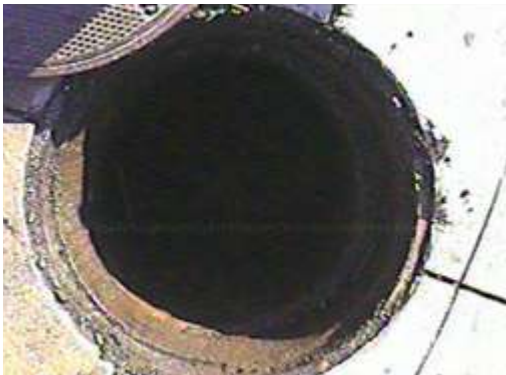
Defect 1

**Frame** Offset: **3** (in.) Condition: ☒ Sound ☐ Cracked ☐ Leaks

frame offset

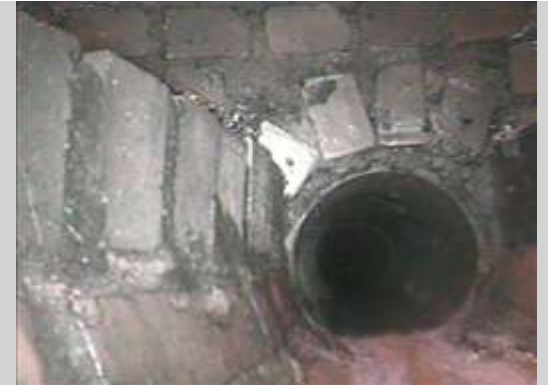
12 O'Clock Outflow

8 in. Circular Gravity Sewer  
Pipe Out @ 12 O'Clock

Pipe Height: (in.) Direct  
Pipe Material: **Clay** ☐ Pipe Lined  
Invert Depth: **11.60** (ft.) Flow Characteristics: **Fast**  
Deposits: ☒ None ☐ Mud ☐ Sludge ☐ Debris ☐ Grease  
Silt Depth: (in.) Deposits Extent:  
Infiltration: **None** Pipe Seal Cond: **Sound**

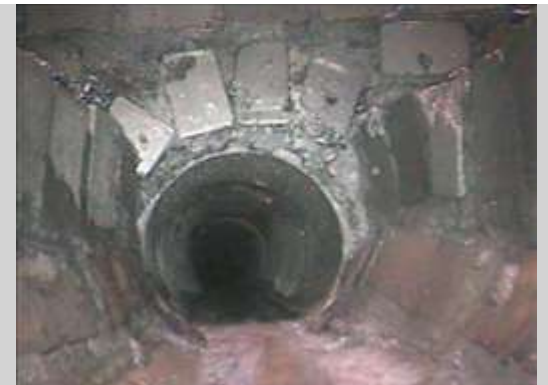
7 O'Clock Inflow

8 in. Circular Gravity Sewer  
Pipe In @ 7 O'Clock

Pipe Height: (in.) Direct  
Pipe Material: **Clay** ☐ Pipe Lined  
Invert Depth: **11.10** (ft.) Flow Characteristics: **Fast**  
Deposits: ☒ None ☐ Mud ☐ Sludge ☐ Debris ☐ Grease  
Silt Depth: (in.) Deposits Extent:  
Infiltration: **None** Pipe Seal Cond: **Sound**
